Residential Development, Fortfield Road, Terenure

Basement Impact Assessment 222102-PUNCH-XX-XX-RP-C-0011

March 2025

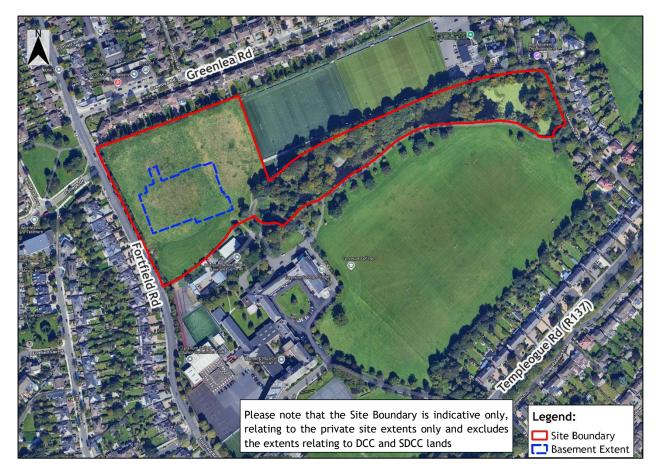
Figure 1-1: Site Location.

Figure 1-1 indicates the location of the subject lands. The site may be additionally located by National Grid Reference 313399 (E), 229777 (N). The extent of the basement perimeter relative to the site boundary is also shown.

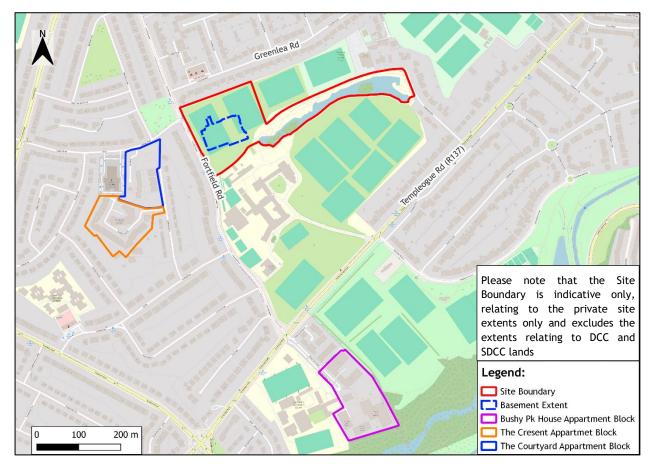
Figure 1-2: Nearby Structures incorporating Basements.

The search findings are highlighted in Figure 1-2.

- 1. Bushy Pk House Apartment Block(s). Existing development with basement.
- 2. The Courtyard Apartment Block(s). Existing development with basement.
- 3. The Cresent Apartment Block(s). Existing development with basement.

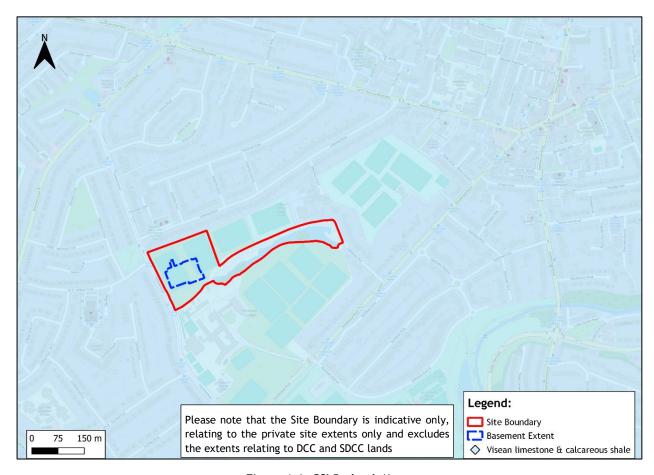
Figure 1-6: GSI Bedrock Map.

The Geological Survey Ireland (GSI) Spatial Resources database shows that the entire site is located on underlying bedrock of 'Visean limestone & calcerous shale'. Figure 1-6 below displays a bedrock map for the proposed development site. GSI database does not indicate the presence of any Karst features on site, however it should be noted karst is a risk in limestone areas.

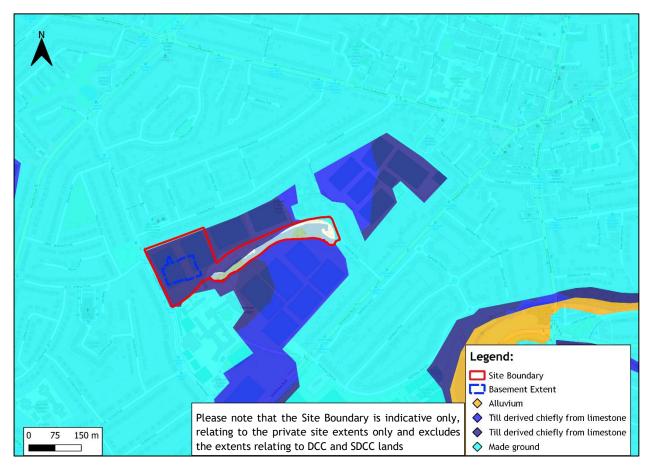
Figure 1-7: Teagasc Soils.

The Teagasc soils are mostly 'Till derived chiefly from limestone' for the majority of the site. It is noted that surrounding areas of the site comprise of 'made ground'. Please refer to Figure 1-7.

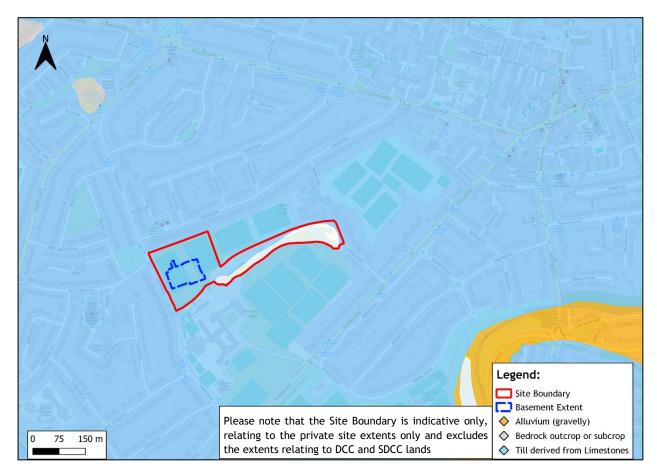
Figure 1-8: Quaternary Sediments.

Published geological mapping obtained from the Geological Survey of Ireland (GSI) database indicate the superficial deposits underlying the site comprise of tills derived from limestone as shown in Figure 1-8. This deposit is underlain by dark limestone and shales of the Lucan Formation.

The subsoils (Quaternary Sediments) at the site location comprise of tills derived from limestone as shown in Figure 1-8. The subsoil permeability is identified as 'Low', with an Average Groundwater Recharge rate of 31 mm/year. There is locally important bedrock aquifer which is moderately productive only in local zones. Please refer to Figure 1-12.

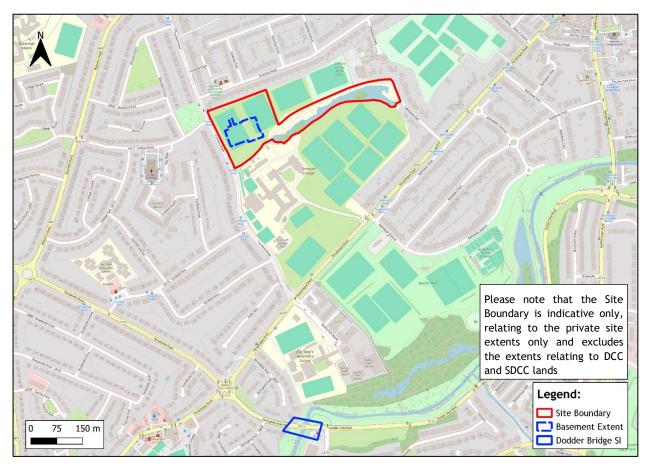
Figure 1-9: Proposed developments location in relation to adjacent SI sites.

A search of the GSI records has identified records of a number of site investigations that were completed on or within the immediate vicinity of the site including one located at Dodder Bridge roughly 760m south of the site (GSI Report: 1015). Please note this was the closest site investigation, that had borehole logs information readily available to view online. Its location relative to the proposed development site is shown in Figure 1-9. This historic site investigation is included in Appendix D. The boreholes indicate similar stratification with topsoil extending from ground level to depths of 0.75m overlying overburden to depths of 19m, overlying rock (carboniferous limestone/ calciferous sandstone) to depths of 25m.

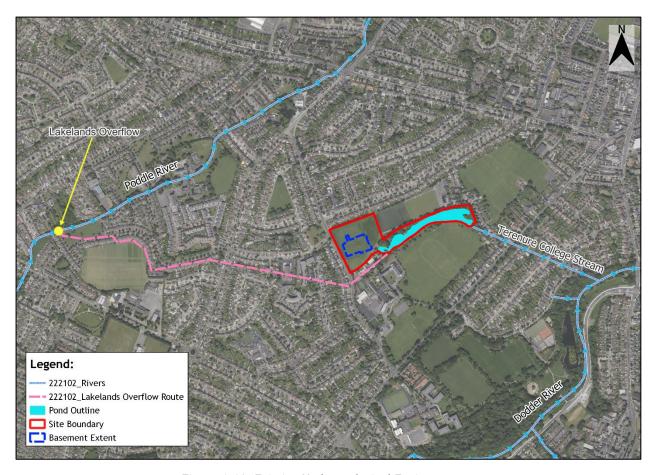
Figure 1-10: Existing Hydrogeological Environment.

The existing hydrological environment is characterised primarily by the presence of an open drainage pond located on the site. According to the drainage records the pond is fed from an existing off-take on the River Poddle, known as Lakelands Overflow, which is located at Wainsfort Manor to the west of the subject site. The overflow is piped underground via a 1230mm x 1230mm concrete box culvert for a distance of 1.4km before discharging into the pond. The pond discharges to the River Dodder located to the southeast of the subject site via a 1450mm x 1480mm concrete box culvert (note as Terenure College Stream on EPA mapping). The existing hydrogeological arrangement is shown in Figure 1-10.

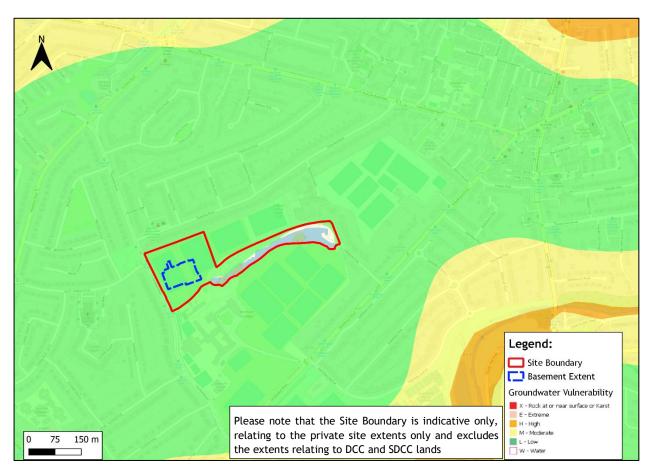
Figure 1-11: National Vulnerability Map.

GSI data shows that much of the site is located over an area of low groundwater vulnerability. It is noted that the entire area surrounding the proposed development site located over an area of low groundwater vulnerability. Please refer to Figure 1-11. The site is also not located within a Groundwater Source Protection Zone.

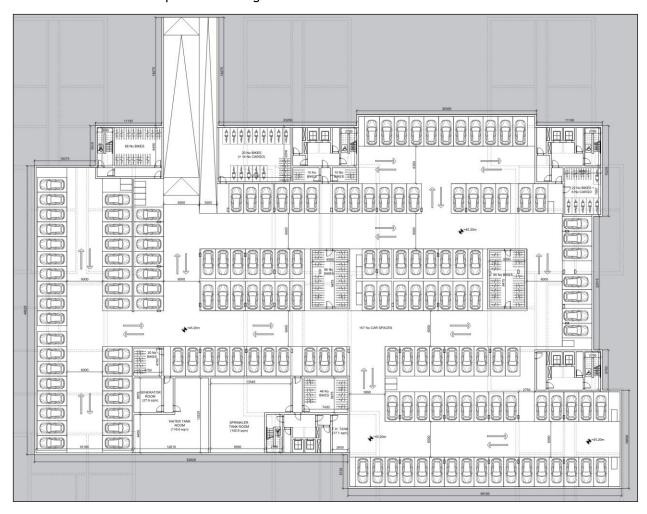
Figure 3-1: Proposed Basement Plan.

An extract of the architects proposed basement plan is shown in Figure 3-1. Please refer to Appendix A for full size architectural plans for both ground and basement level.

The development will comprise a Large-Scale Residential Development (LRD) on a site at Fortfield Road, Terenure of 284 no. units delivering 19 no. houses and 265 no. apartments made up of studios; 1 beds; 2 beds; 3 beds; and 4 beds. Provision of car, cycle and motorbike parking will be provided throughout the development, including at basement and surface level. The basement will extend to a depth of 44.80m OD (formation level). Existing ground levels on site for where the basement is positioned are approximately 47.50m OD, meaning the basement will have a depth between 2.70m below existing ground levels.

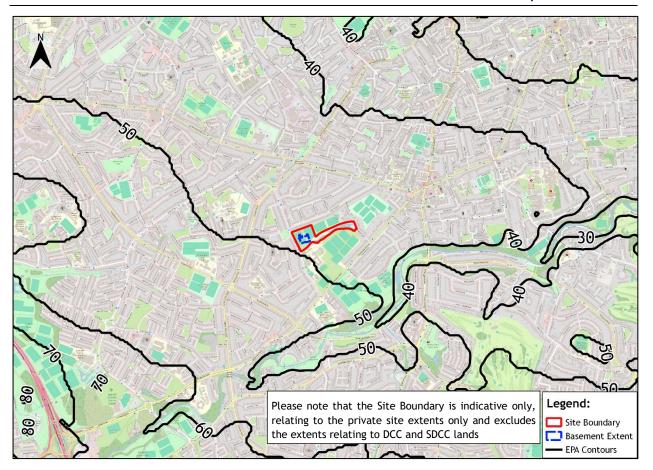
Figure 3-2: Groundwater Contours (GSI/EPA Online Database).

The closest available groundwater contour to the south-west of the site is approximately 30m from the site and is noted as +50m OD. To the north of the site, the groundwater contour at approximately 940m from the site, close to Kimmage, is noted as +40.0m OD. The site is located closer to the +50m OD contour. The groundwater monitoring on site will be reviewed and compared with the published contour information. The general hydraulic gradient across this part of Dublin is approximately 0.01 (or 10m fall in groundwater level over 1km).

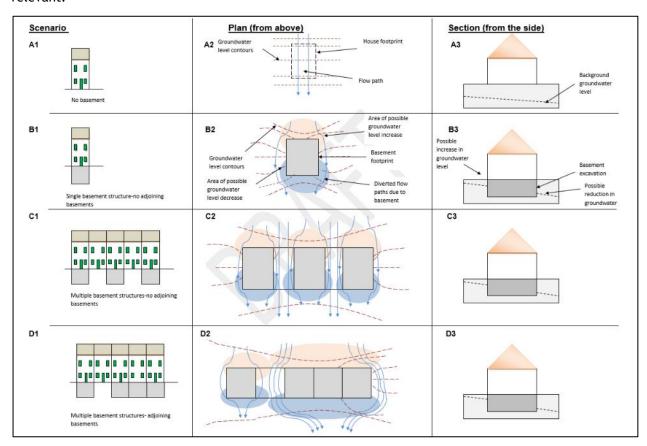
Figure 3-3: Cumulative Effects of Basement Construction on Hydrogeology (ref: Appendix 9 of the Dublin City Development Plan 2022 - 2028 "Basement Development Guidance")

The proposed development at Fortfield Road is not considered to have an impact on existing basement structures such as, The Courtyard Apartment Block(s) (existing development with basement) or The Cresent Apartment Block(s) (existing development with basement). This is due to them not being in the immediate vicinity of the proposed development site at Fortfield Road. It is therefore considered that that Scenario B1 illustrating the principle of groundwater flow around a single basement structure is relevant.

The diversion of flow paths around the basement structure would be expected to lead to a marginal increase in groundwater levels upstream, and a similar reduction in groundwater levels downstream. The increase is a function of the width and depth of the basement and the permeability of the underlying soils.

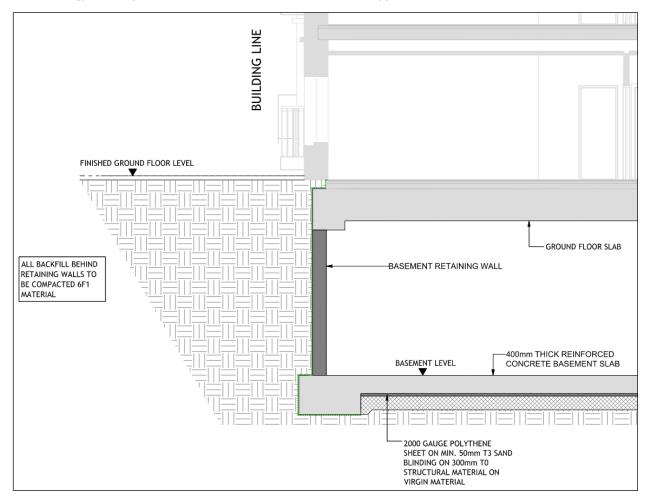
Figure 3-4: Proposed Basement Section

Essentially the sequence may be considered as three groups of activities, the first comprising the short-term 'open cut' bulk excavation, the second consisting of the installation of the basement structure permanent works and the third represents the backfilling of the open excavation.

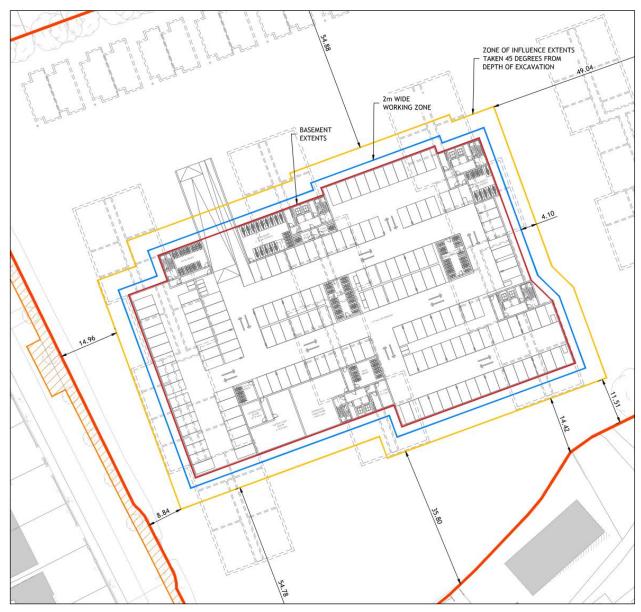
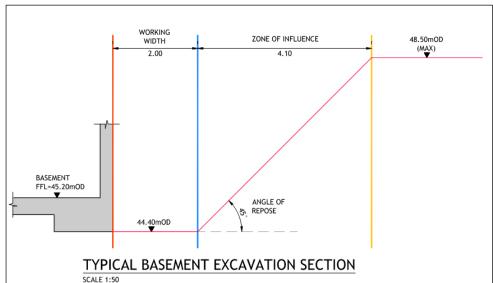
Figure 3-5: Extracts from PUNCH Drawing 222102-PUNCH-XX-XX-DR-C-0130 illustrating Zone of Influence in Plan and Typical Section (Angle of Repose = 45 degrees)

The 'Zone of Influence' associated with this excavation does not extend to any existing structures or adjacent properties. In fact, the 'Zone of Influence'- whether indicated by a 45 or 30 degree angle of repose - has a large offset to the site boundaries as illustrated in PUNCH Drawings 222102-PUNCH-XX-XX-DR-C-0130 and 222102-PUNCH-XX-XX-DR-C-0131. Refer to Appendix G for drawings.

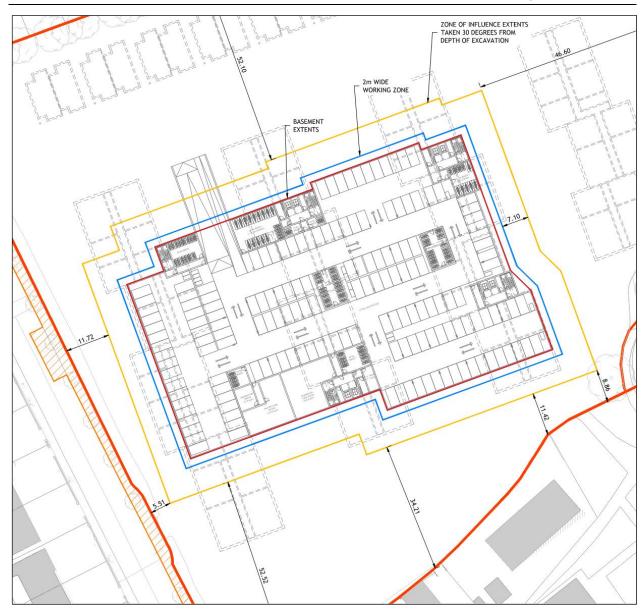
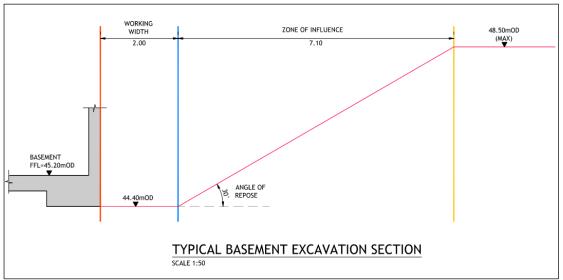
Figure 3-6: Extracts from PUNCH Drawing 222102-PUNCH-XX-XX-DR-C-0131 illustrating Zone of Influence in Plan and Typical Section (Angle of Repose = 30 degrees)
