**Residential Development, Fortfield Road,
Terenure**

**Basement Impact Assessment
222102-PUNCH-XX-XX-RP-C-0011**

December 2024

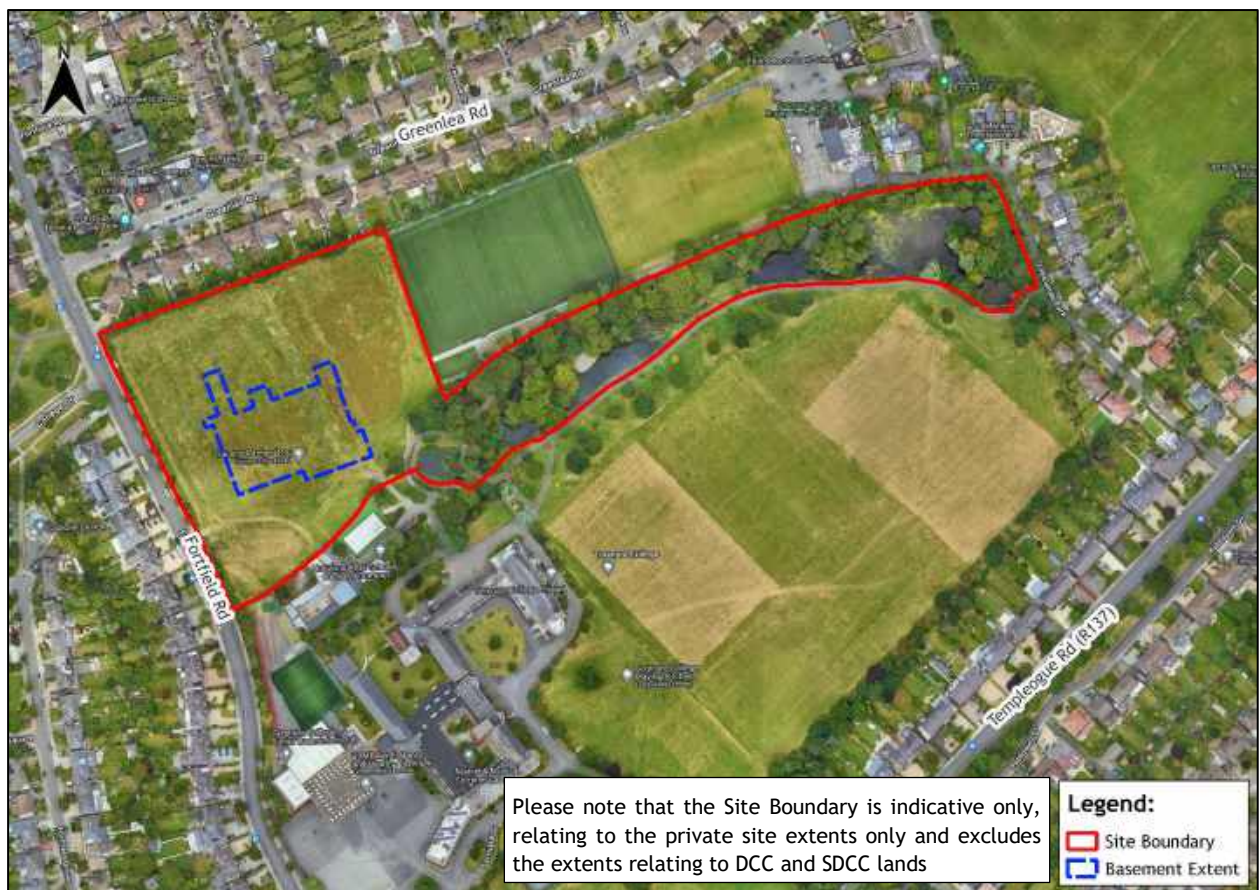
Figure 1-1: Site Location.

Figure 1-1 indicates the location of the subject lands. The site may be additionally located by National Grid Reference 313399 (E), 229777 (N). The extent of the basement perimeter relative to the site boundary is also shown.

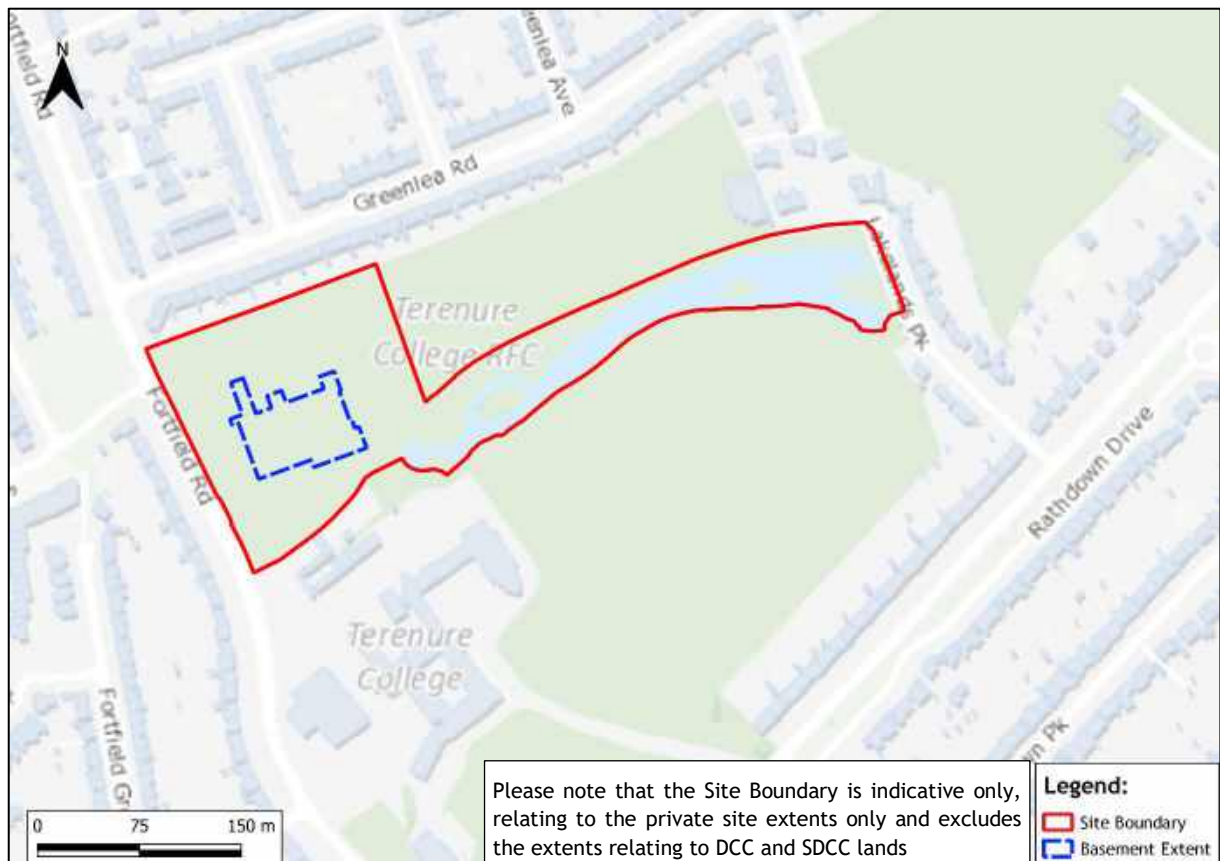
Figure 1-5: GeoHive Map 2024.

The current iteration of development on site, comprises of a brownfield, consisting of former sports pitches, as shown in Figure 1-5.

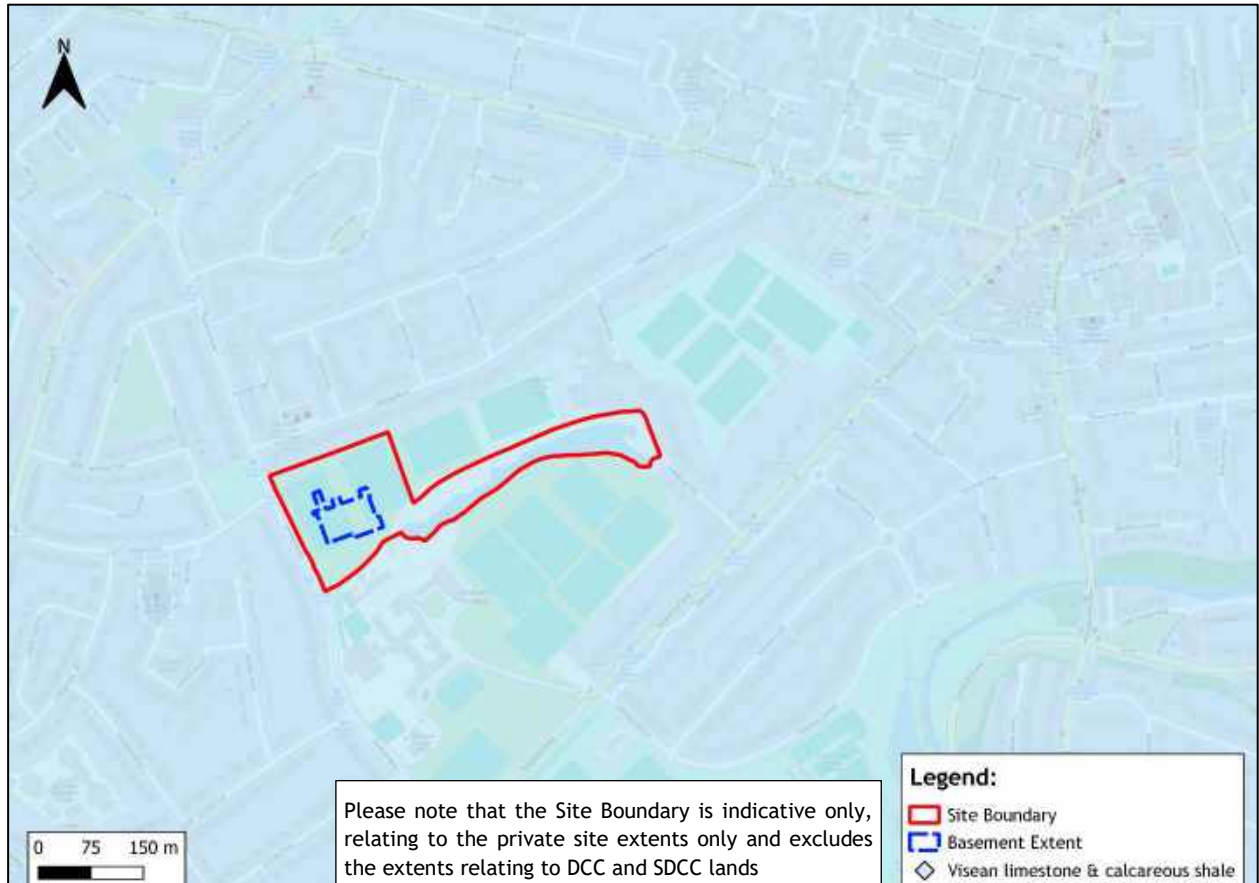
Figure 1-6: GSI Bedrock Map.

The Geological Survey Ireland (GSI) Spatial Resources database shows that the entire site is located on underlying bedrock of 'Visean limestone & calcareous shale'. Figure 1-6 below displays a bedrock map for the proposed development site. GSI database does not indicate the presence of any Karst features on site, however it should be noted karst is a risk in limestone areas.

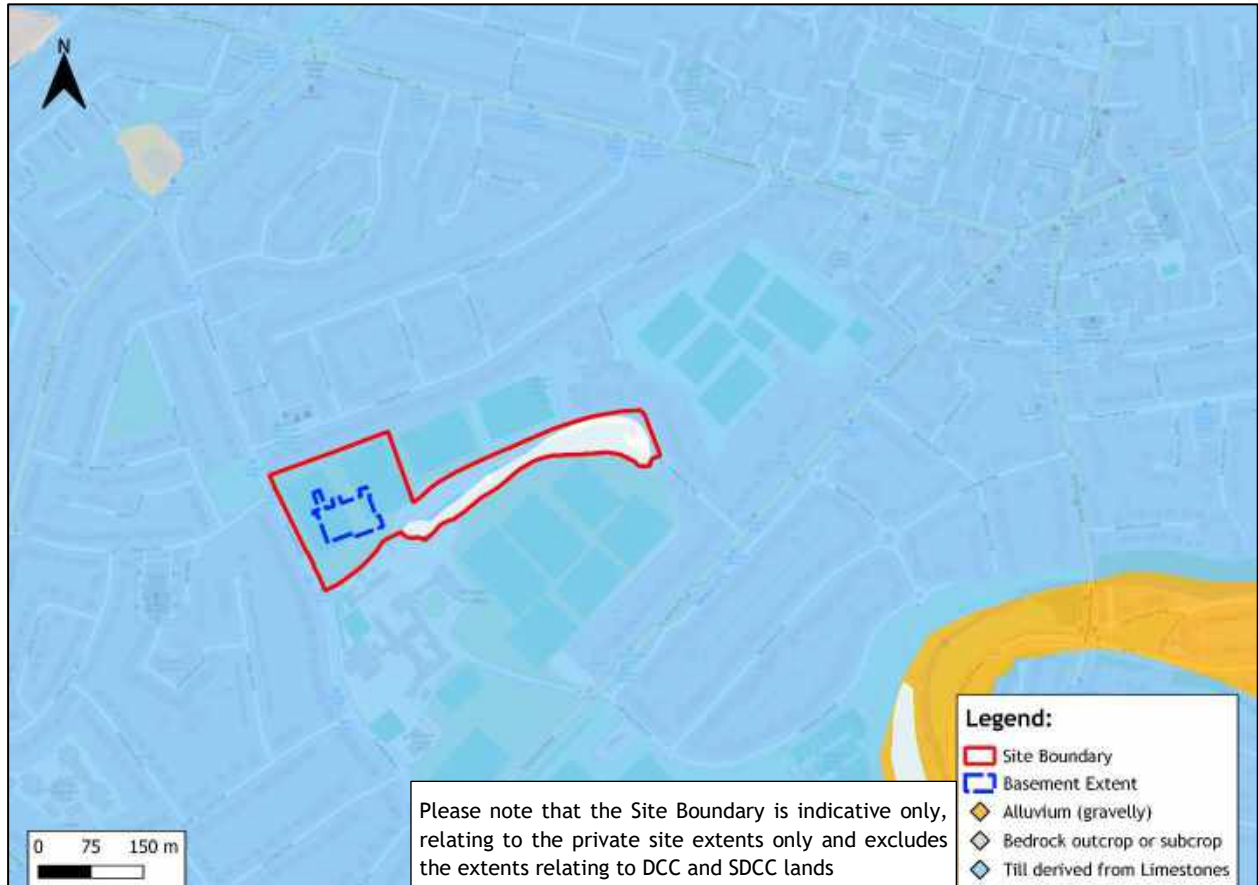
Figure 1-8: Quaternary Sediments.

Published geological mapping obtained from the Geological Survey of Ireland (GSI) database indicate the superficial deposits underlying the site comprise of tills derived from limestone as shown Figure 1-8. This deposit is underlain by dark limestone and shales of the Lucan Formation.

The subsoils (Quaternary Sediments) at the site location comprise of tills derived from limestone as shown in Figure 1-8. The subsoil permeability is identified as 'Low', with an Average Groundwater Recharge rate of 31 mm/year. There is locally important bedrock aquifer which is moderately productive only in local zones. Please refer to Figure 1-12.

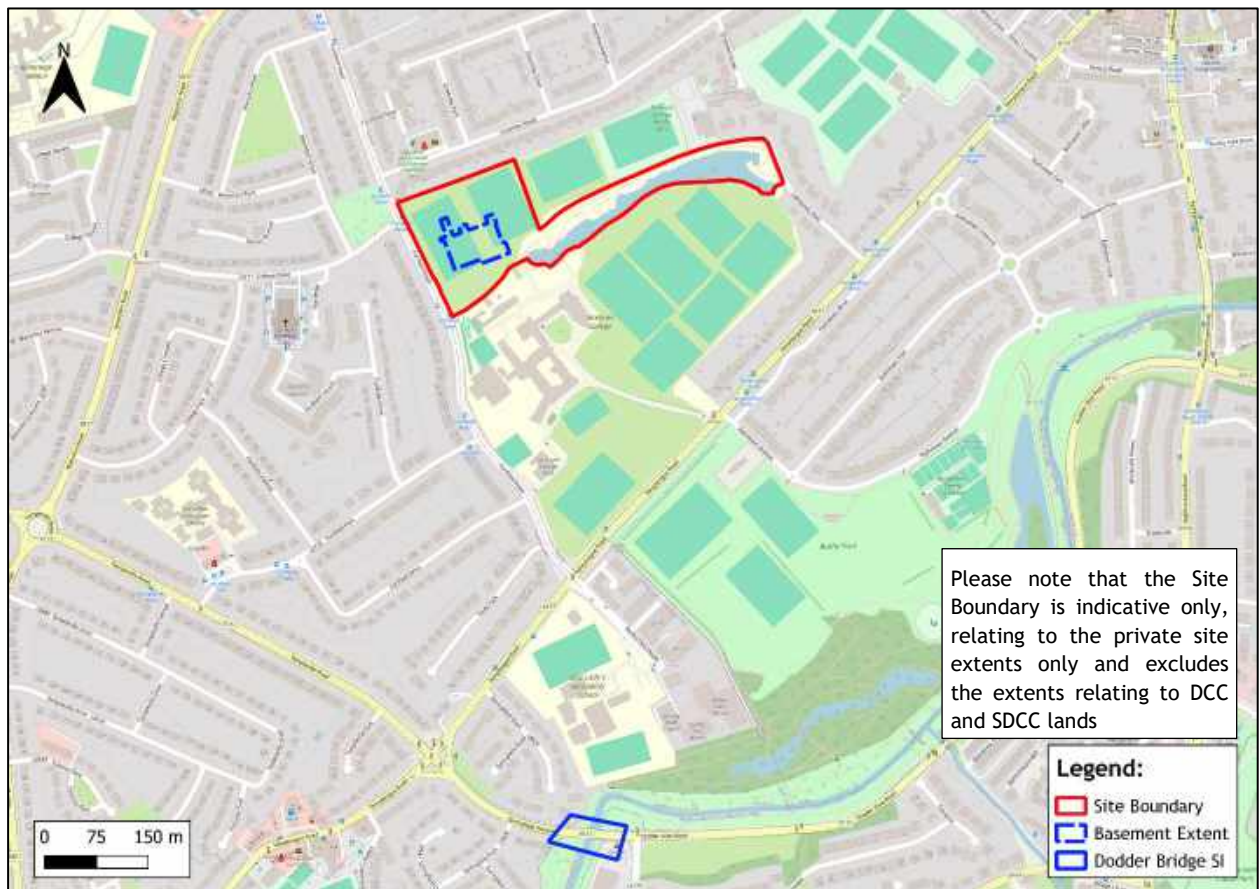
Figure 1-9: Proposed developments location in relation to adjacent SI sites.

A search of the GSI records has identified records of a number of site investigations that were completed on or within the immediate vicinity of the site including one located at Dodder Bridge roughly 760m south of the site (GSI Report: 1015). Please note this was the closest site investigation, that had borehole logs information readily available to view online. Its location relative to the proposed development site is shown in Figure 1-9. This historic site investigation is included in Appendix D. The boreholes indicate similar stratification with topsoil extending from ground level to depths of 0.75m overlying overburden to depths of 19m, overlying rock (carboniferous limestone/ calciferous sandstone) to depths of 25m.
