Appendix A Topographic Survey

Project : Lakelands Terenure

Description : Topographical Survey

Appendix B Site Visit Images

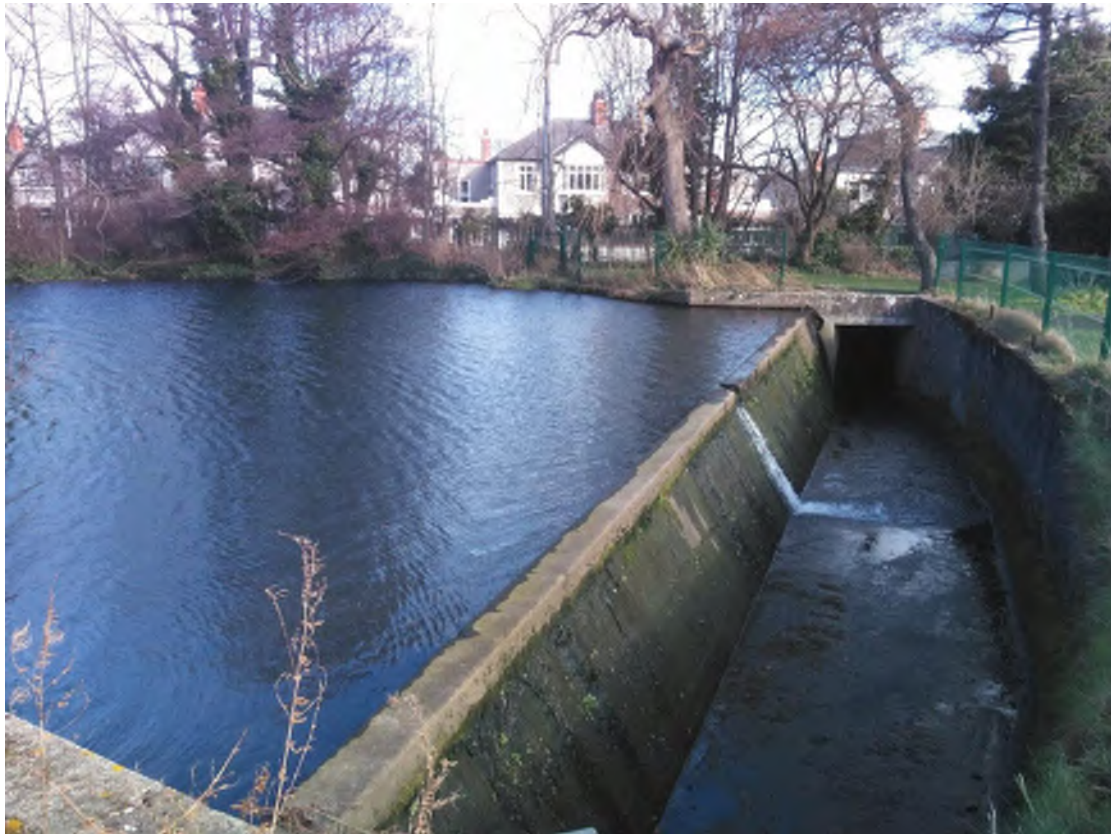
Image 1: Existing pond on site - Downstream Overspill and Discharge from site

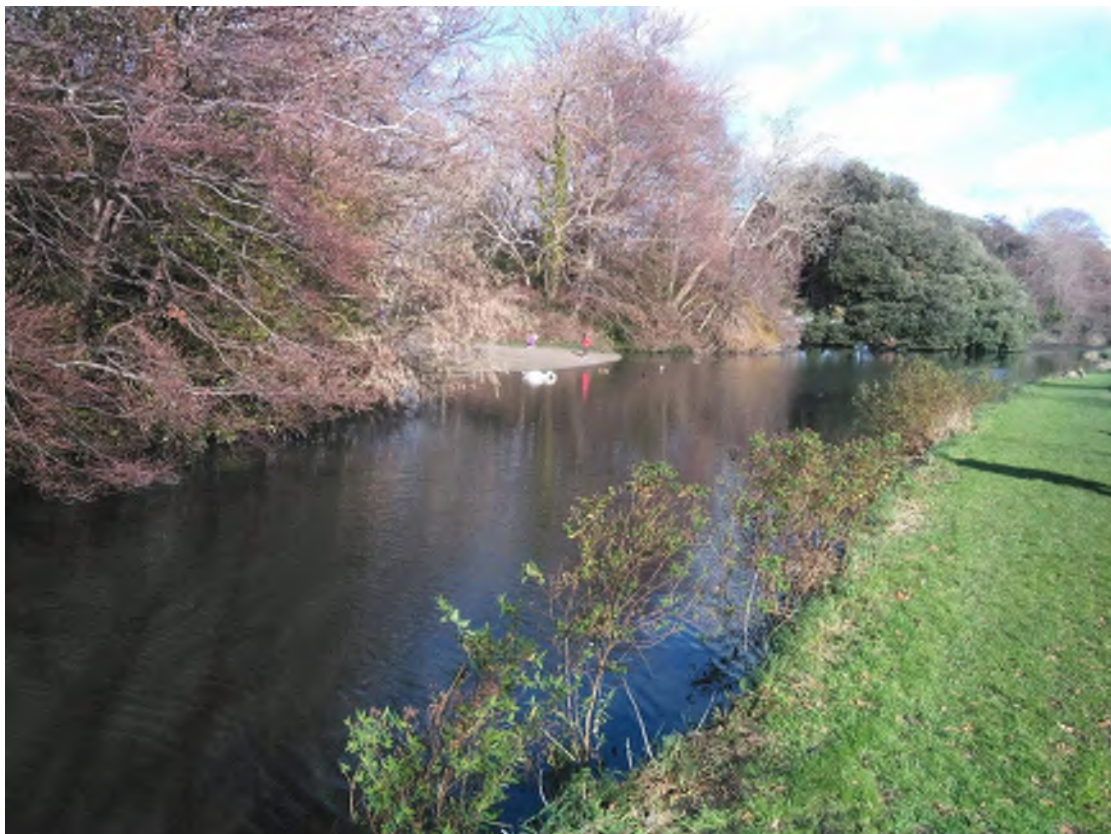
Image 2: Existing pond on site

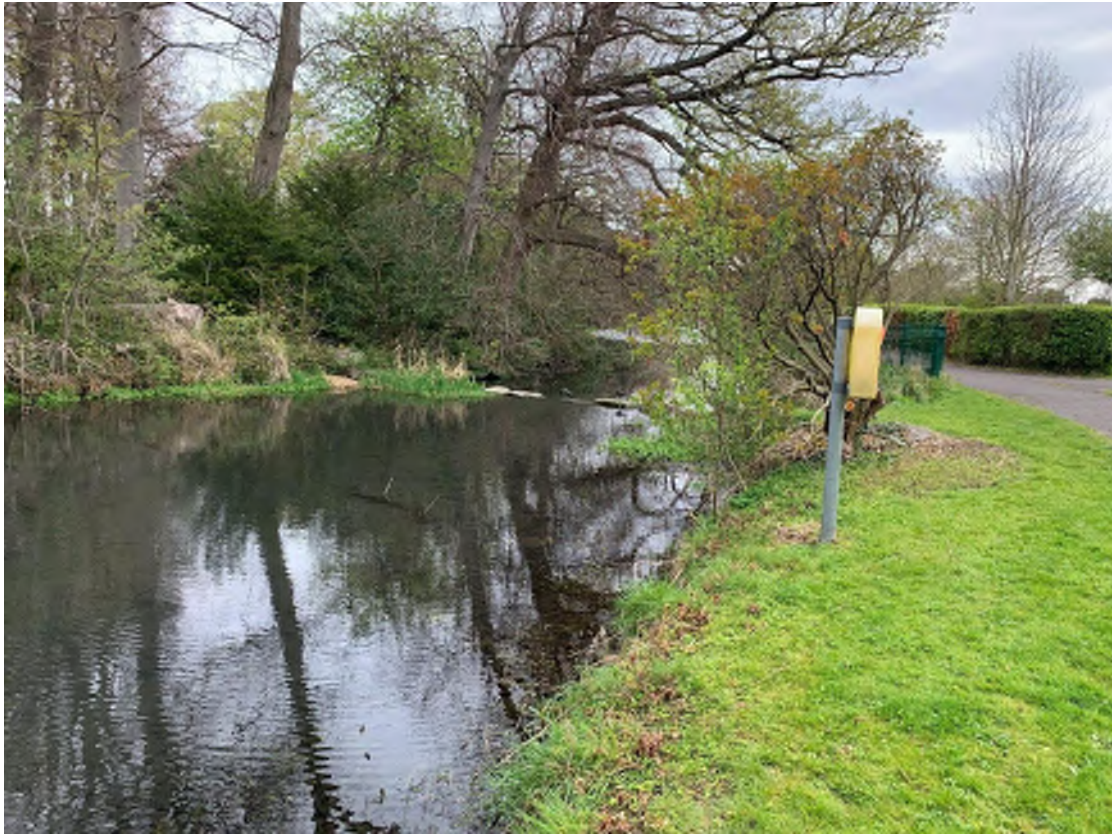
Image 3: Existing pond on site - Looking Downstream

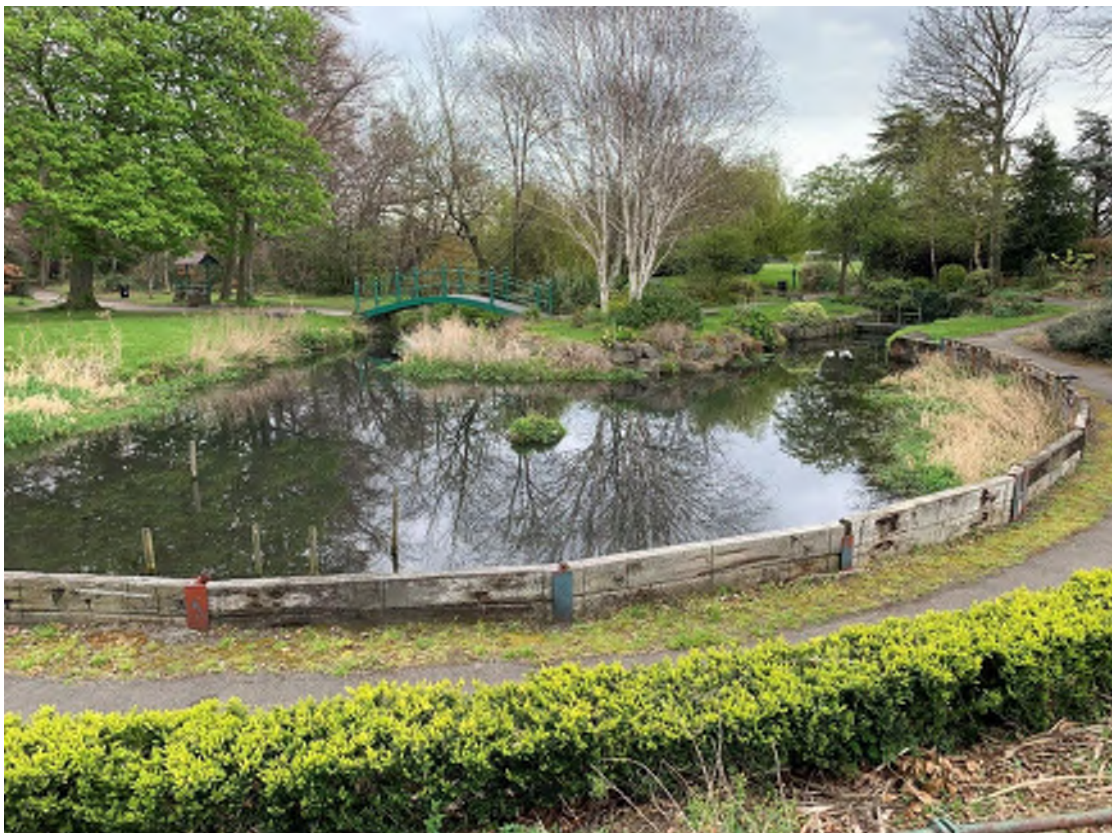
Image 4: Existing pond (Upstream)
