Residential Development, Fortfield Road, Terenure

Existing Pedestrian Bridge Inspection and Assessment Report 222102-PUNCH-XX-XX-RP-C-0010

November 2024

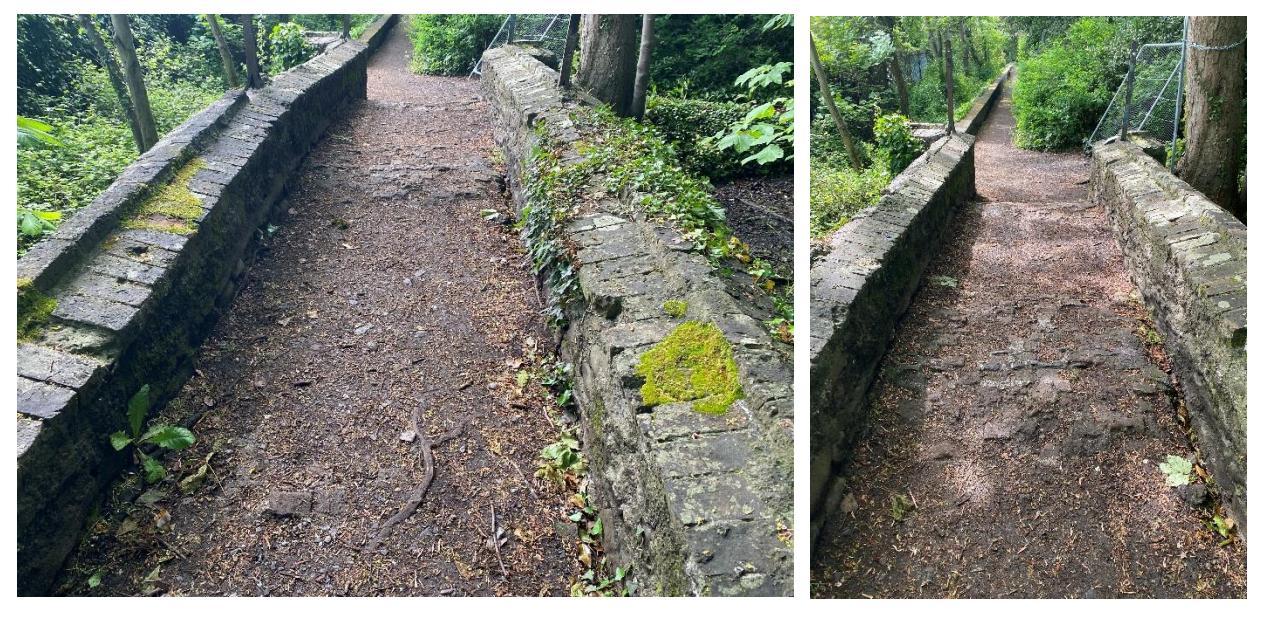
Figure 2 - Bridge Surface

The bridge surface is in poor condition. The wearing course is deteriorating or non-existent in places with the arch barrel exposed in places, representing a tripping hazard. It is recommended that replacement of the bridge surfacing is undertaken in accordance with the landscape architectural recommendations, with the provision of a 100mm thick wearing surface build-up throughout the bridge extents.

- 4) Provision of a 100mm thick wearing surface build-up throughout the bridge extents is recommended. This should be specified in consultation with landscape architectural recommendations.

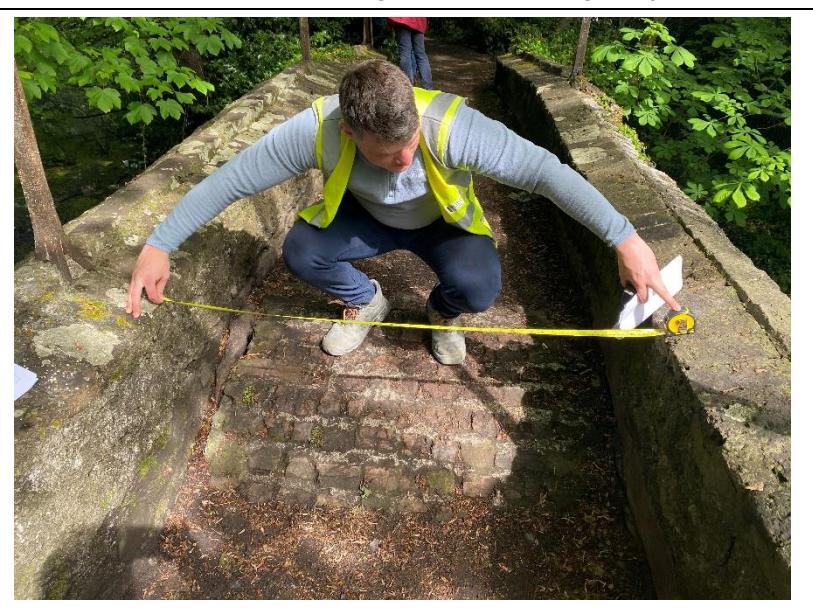
Figure 3 - Narrow Width of Bridge

The masonry arch structure serves to carry a narrow (1.2m wide between parapets) pedestrian pathway over the local watercourse at this location.

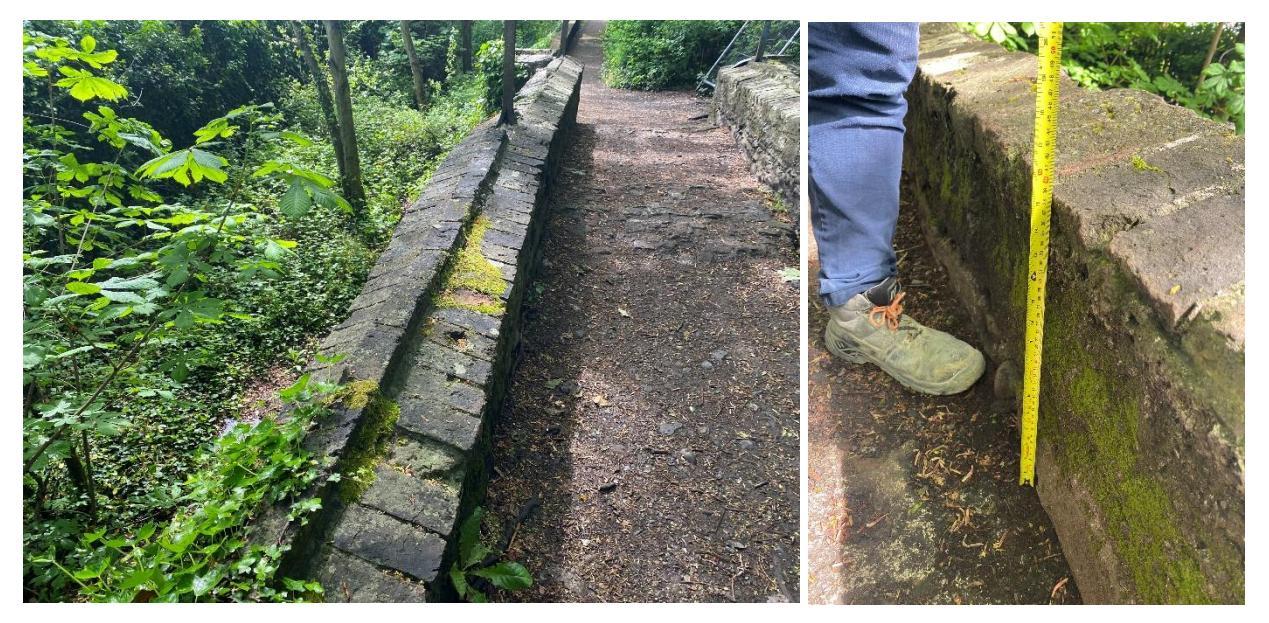
Figure 4 - Short Parapet Height

The parapet wall is typically in the order of 400mm high relative to the existing bridge surface. The introduction of 100mm depth of new surfacing will further reduce the height of the parapet to 300mm relative to the walking surface.

The parapet wall is in reasonably good condition. Some localised masonry loss and damage observed to coping.

- 5) An assessment of pedestrian safety in the context of low height parapet walls is recommended. This would benefit from consultations with a conservation architect.

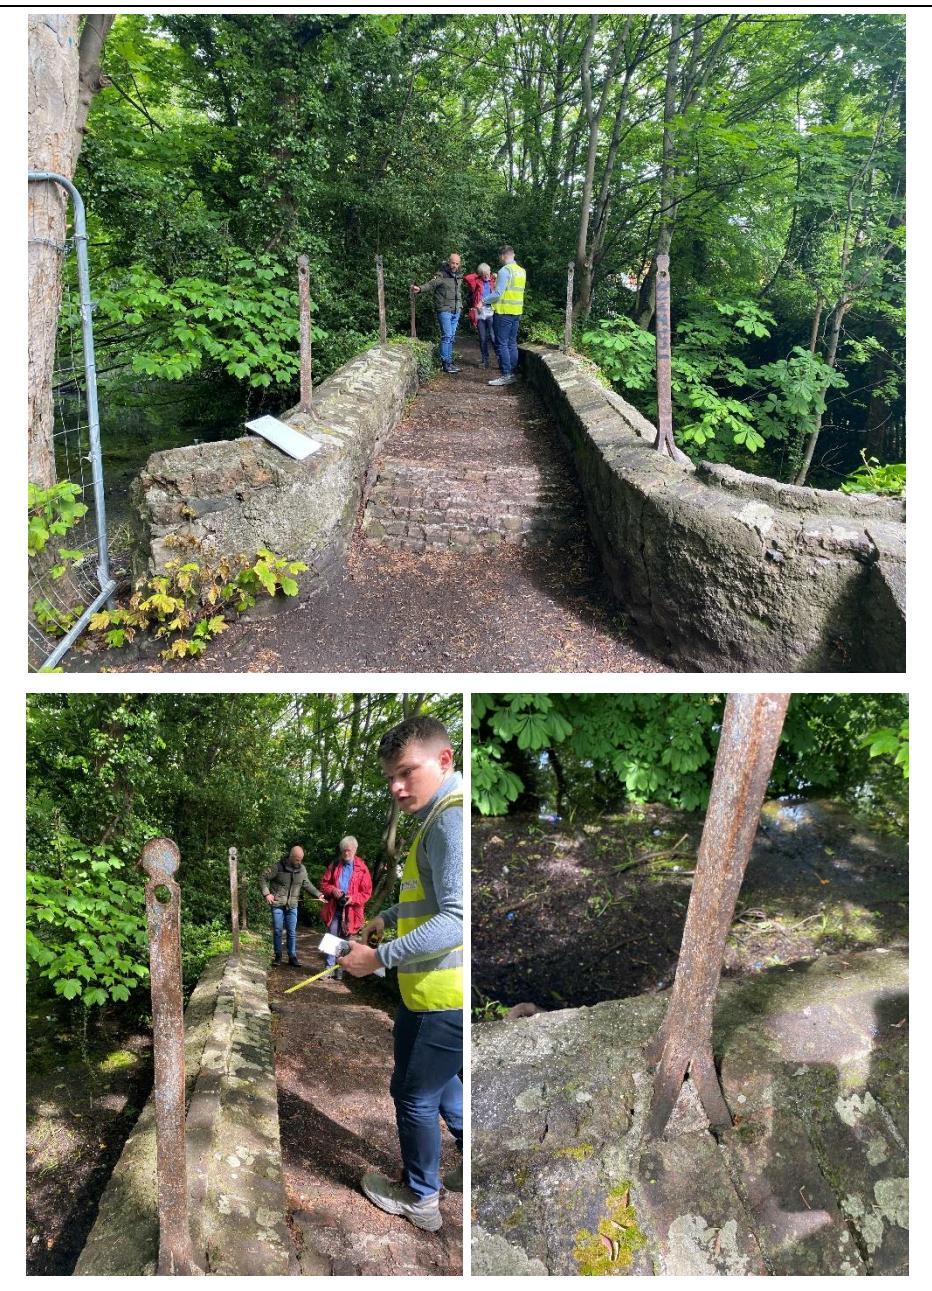
Figure 5 - Historic Iron Posts

Iron posts are cast into the parapet at regular 3m intervals. It is presumed that a chain previously ran between these posts to offer additional restraint to pedestrians.

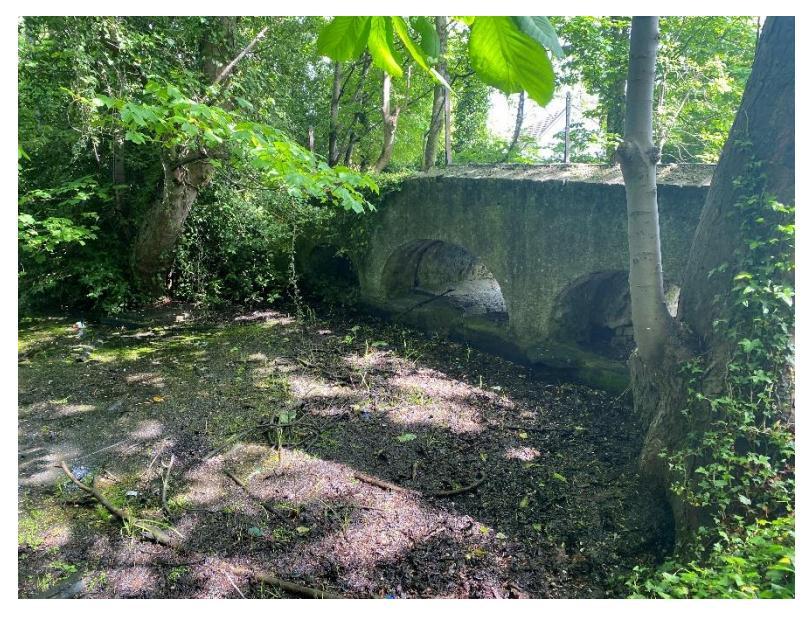
Figure 6 - Western/Upstream Spandrel Wall

The western spandrel walls appear in good condition with no significant cracking or bulging observed on this upstream bridge elevation.

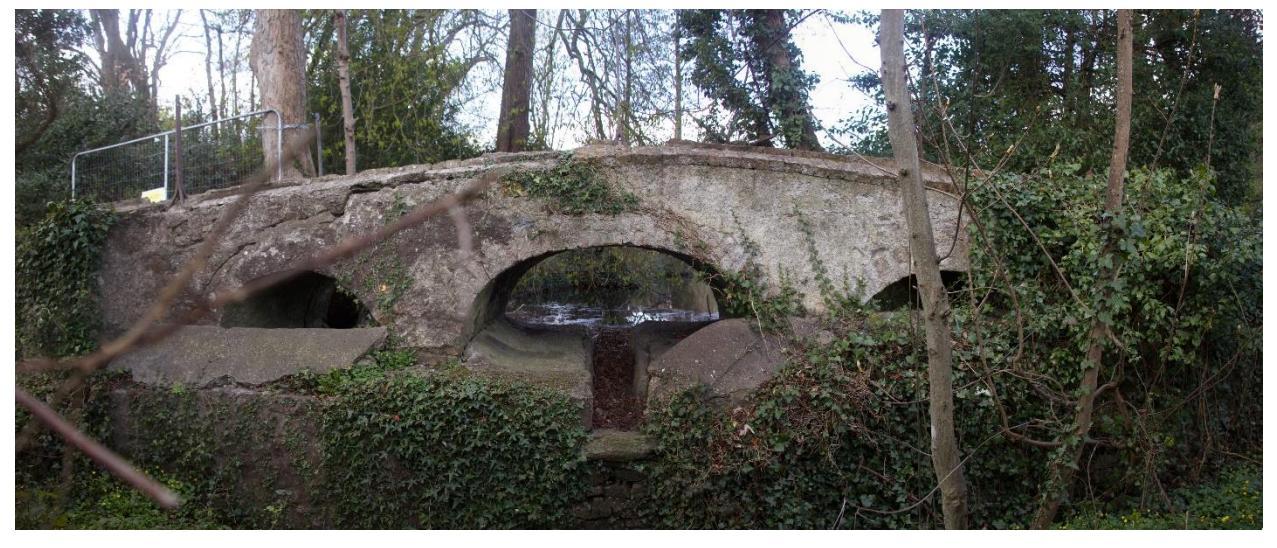
Figure 7 - Eastern/Downstream Spandrel Wall

The eastern spandrel walls appear in good condition generally with no significant cracking or bulging observed on this elevation for the Spans 2 and 3 extents. However, there is a significant diagonal crack observed over the Span 1 arch. This longitudinal crack has been previously patched with mortar, obscuring the width and depth of the cracking in the previous mortar joints.

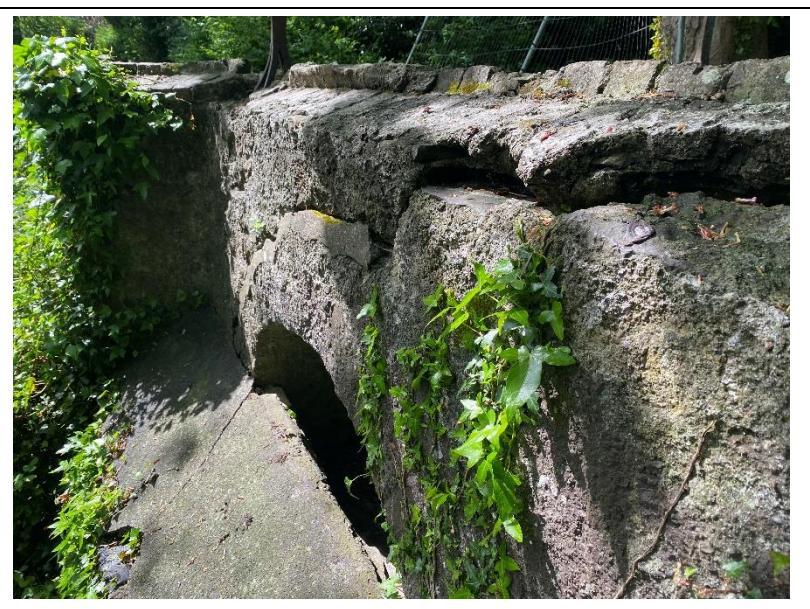
Figure 8 - Crack in Parapet and Spandrel Wall over Span 1 (Eastern Elevation)

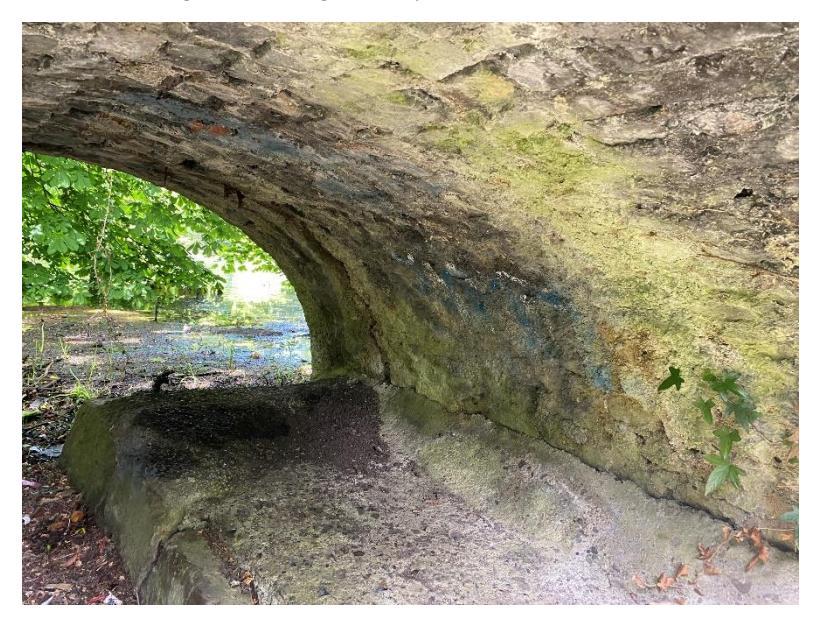
Figure 9 - Span 2 Arch Barrel

The arch barrels do not exhibit any significant transverse or longitudinal cracking with the exception of a longitudinal crack in Span 2 coinciding with the western parapet. There is widespread mortar loss throughout the arch barrels. The joints between barrel stones are insufficiently filled to depths in the range of 10-20mm. The remaining mortar is generally loose and friable.

- 3) Repointing is recommended throughout the bridge at multiple locations, particularly to the arch barrels on all three spans. The loss of mortar throughout the arch barrels leads to a loss of strength to the bridge arches in the analyses. The loss of mortar also accelerates the deterioration of the arch over time, increasing the risk of arch separation and stone displacement in the barrel. A lime-based mortar is recommended.

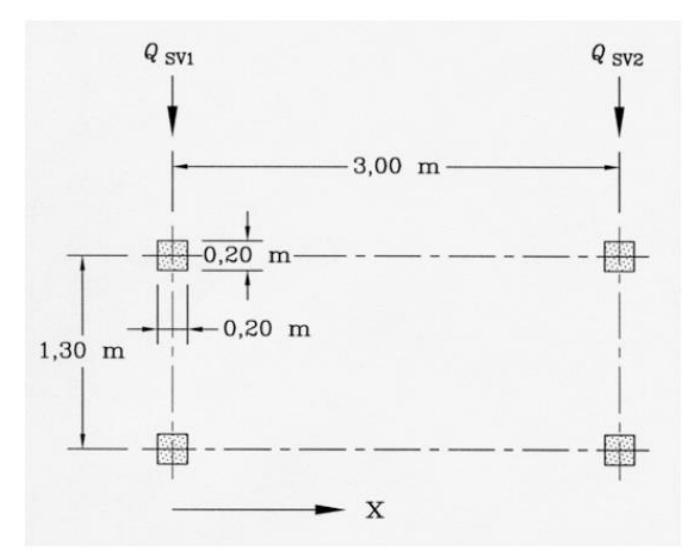
The effect of the 12.5 tonnes gross vehicle weight 2 axle HGV can be assessed using the Service Vehicle load model as presented in clause 5.3.2.3 of I.S. EN 1991-2+NA:2009 Eurocode 1: Actions on structures - Part 2: Traffic loads on bridges (Including Irish National Annex). The graphical representation of this Service Vehicle is included below, it is noted the 120 kN of force represents 12.2 tonnes of mass which is closely comparable to the 12.5 tonnes limiting HGV of Span 2.
